Sextupole Leaky Hose Fittings Fix Proposal (280 sextupoles = 560 hose assemblies)
By Mark Jaski and Jim Humbert
April 7, 2004

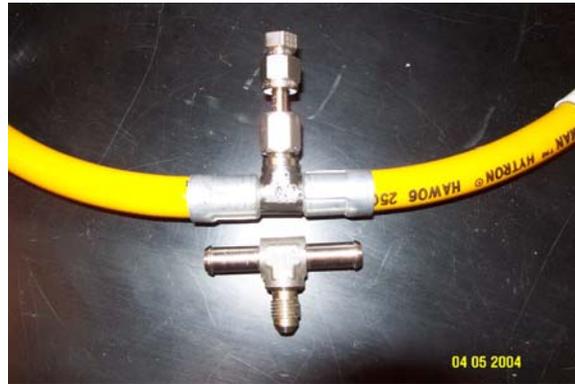
Problem: The storage ring sextupoles are hoses with crimp style 4 explained below. These hoses are beginning to leak and need replacing. Just touching or moving the hose can cause a leak. The probability of this hose causing storage ring downtime is high.

- Crimp style 1 (ideal) – three barb fitting with brass ferrule with four ribbed crimp. I cannot twist it or make it leak at 250 psi.
- Crimp style 2 – one barb fitting with brass ferrule four ribbed crimp. I can twist the hose in the fitting but cannot make it leak at 250 psi.
- Crimp style 3 – one barb fitting with aluminum ferrule with double flat crimp. I can twist the hose in the fitting and make it leak at 250 psi.
- Crimp style 4 (existing) – one barb fitting with aluminum ferrule with single flat crimp (see figure 1). I can twist the hose in the fitting and make it **EASILY** leak at 250 psi.
- Crimp style 5 – replace aluminum ferrule with hose clamp. The hose clamp causes the barb to cut through the inside of the hose. If this happens it **EASILY** leaks at 250 psi.

Figure 1: Crimp style 4 - One barb fitting with aluminum ferrule with single flat crimp.

1. Purchase 600 brand new hose assemblies with three barb fittings and crimp style 1.
2. Replace 50 hoses per shut down.
3. Will take 4 years
4. Cost \$180,000 for hose assemblies

Any crimp style mentioned above other than crimp style 1 is a poor quality fix. Method 1 is the best way to fix this problem. I recommend fixing the sextupole hoses using method 1.
